All 9 Cutter

P/N: ART.593.535.0

028-71352879

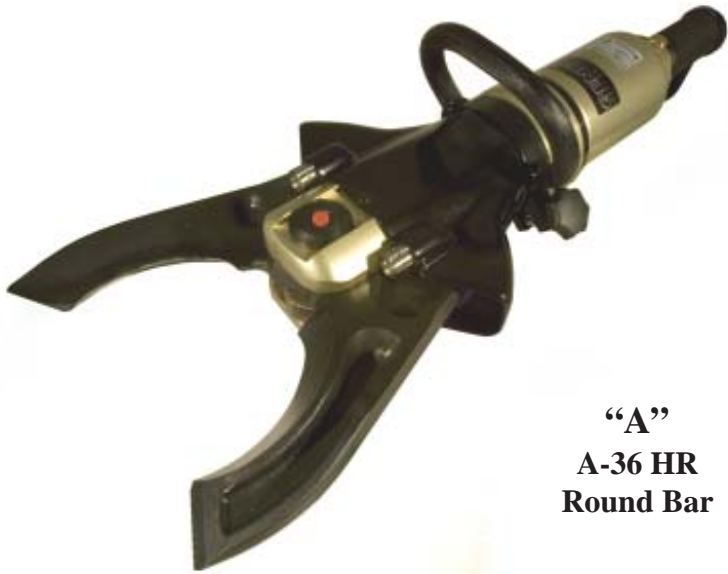
Length (in/mm):	33.7/855
Width (in/mm):	10.8/273
Height (in/mm):	9.2/234
Weight (lbs/kg):	48.3/21.9
Max. Opening (in/mm):	7.1/180
Max. Cutting Force (lbs/kN):	369,000/1640
Max. Op. Pressure (psi/bar):	10,500/720
NFPA Compliant:	Yes
NFPA 1936 Level Rating:	A9/B9/C9/D9/E9
